# **Final Report**

## **Shearography NDE of NASA COPV**

**Tests Performed at NASA  
White Sands Test Facility, NM  
Sept. 12-16, 2006**

**Prepared By  
John W. Newman  
October 25, 2006**

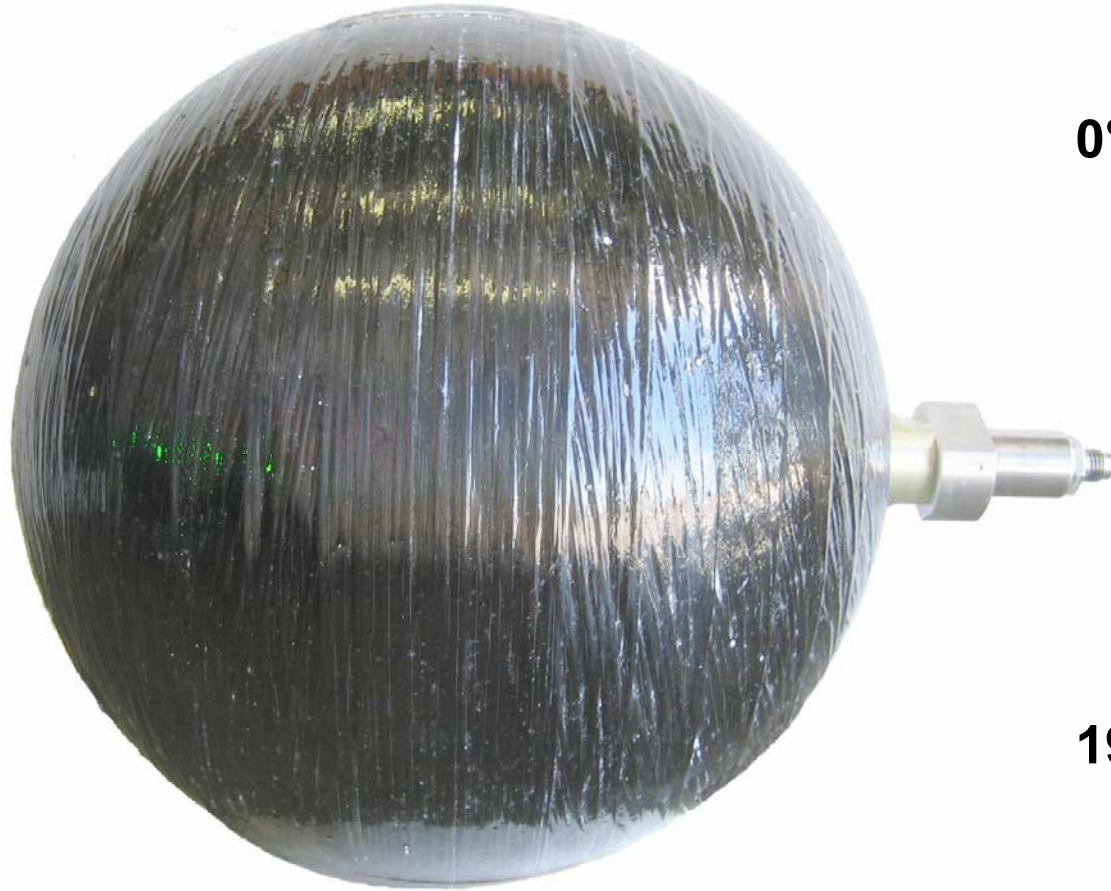
**10 Inch Diam. Carbon Fiber COPV – Typical Images** Stress Concentration Around Boss  
Side View Showing Pressure Fitting  
Shearography Test, at right with  
1.2 psid, rotating 190 Degrees per test.

No visible damage except 0.15 inch diameter dimple at impact sites.
